Solid and

safe

Typical long-distance vessels are often made of aluminium and are designed for the high seas, the tropics or the Arctic Ocean. Many of these yachts are sailed for tens of thousands of miles and their structure is usually as firm as on the first day, even after hard continuous use. Why are they particularly suitable for these extreme applications? How are they built, and what do old models look like? Ralf Weise gives us some insights.

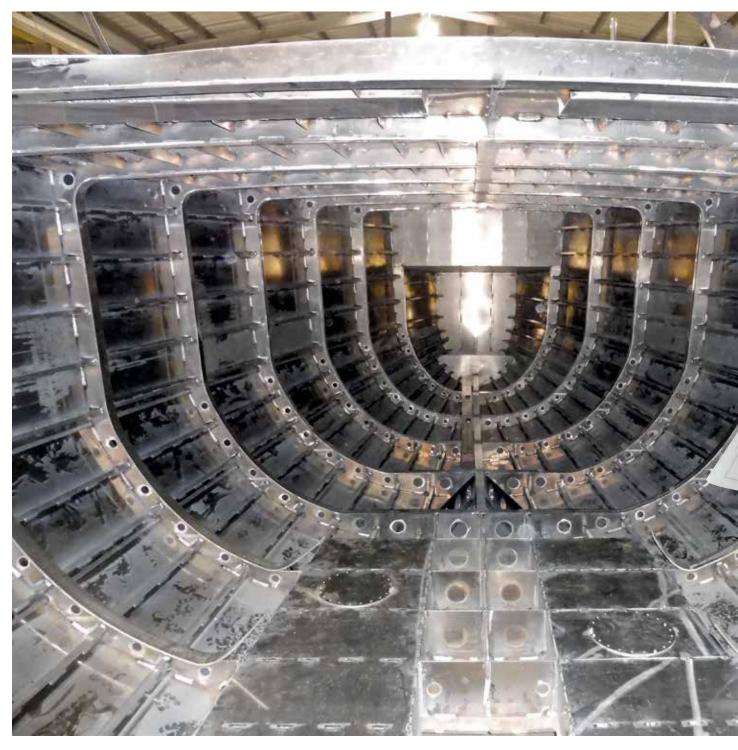
Large photo: The impressive interior of a 53-foot Berckemeyer Design aluminium hull under construction. The large number of welding seams gives an idea of how complex the production process is.

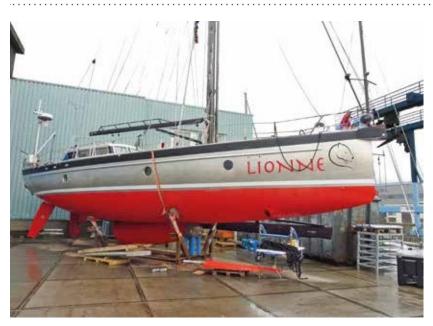
Completed Bestevaer 45.

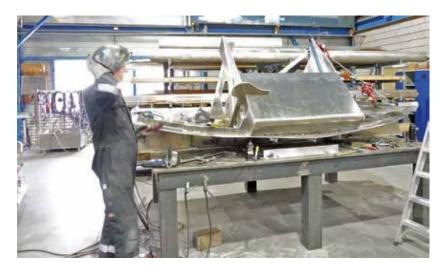
It is tried and tested practice not to build the mirror directly together with the hull, but only to assemble it as an entire component and to weld it in a precisely aligned manner.

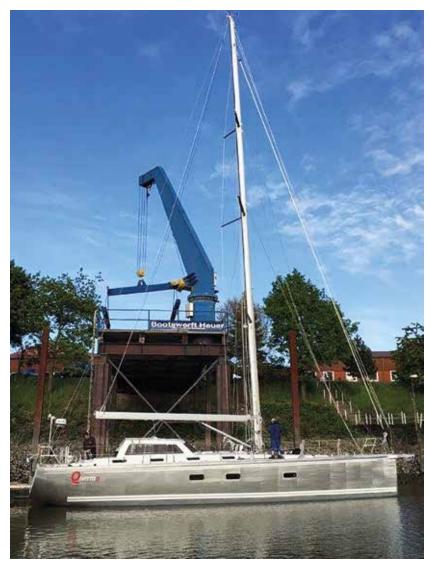
This Judel-Vrolijk design was also built by Benjamins.
